December 28, 2010

Subject: All Pilgrims Church, Seismic Evaluation/Upgrade

The following report presents a summary of our observations and recommendations regarding the Seismic Evaluation/Upgrade of All Pilgrims Church located in Seattle, Washington.

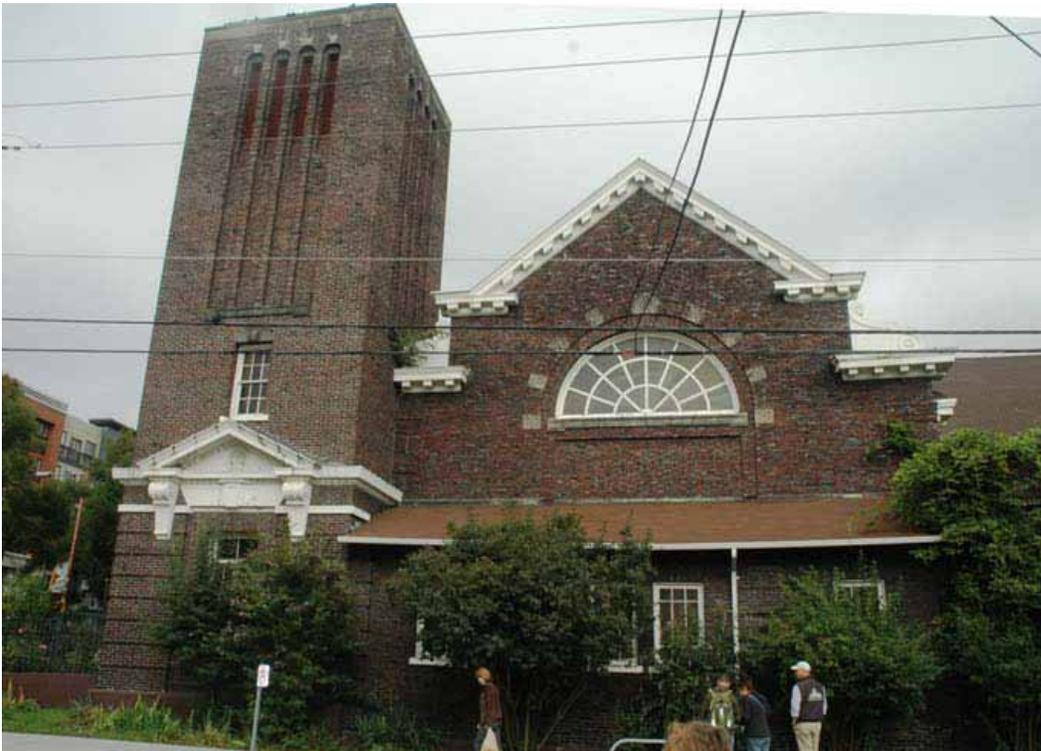
Photo 1: 1906 Sanctuary and Bell Tower – South Elevation

adjoining two-story chapel is approximately 21 ft by 40 ft in plan. Overall height to the peak of the gable roof is roughly 40 feet. There are exposed masonry gable end walls on the south and west sides of the building that extends above the roofline. The north side contains a smaller gable end wall due to the configuration of the altar area. The east gable end wall originally abutted an adjacent building and is now incorporated into the roof/attic of the 1928 addition. See Photos 1 and 2.

The sanctuary and chapel are in fair to good structural condition. The floors appear reasonably level. There are signs of water infiltration at various locations on the exterior walls. This most likely will lead to the discovery of wood rot at the roof deck that would most likely be repaired at the next re-roof. The amount of rot is difficult to determine without removing the roofing. The repair will most likely consist of replacement in-kind.

The entry area at the southwest corner of the sanctuary appears to have settled, as the floor is sloped in this area and there is cracking in the brick exterior. At this time the settlement is more of a nuisance issue requiring repair of finishes. If the church desires, the settlement could be minimized by underpinning the exterior wall with helical or pin piles attached to the concrete footing.

The 1906 sanctuary and chapel portion of the church is an unreinforced masonry (URM) bearing wall structure with flexible roof and floor diaphragms. Previous earthquakes have shown that without a seismic upgrade, this type of building performs poorly in large earthquakes. This portion of the church is particularly susceptible due to the fact that the walls are thin relative to their height and poorly connected to the roof and floor. This causes the walls to become susceptible to falling away out-of-plane, which may lead to localized or total collapse of the roof and floor, creating a life safety issue. Additionally, the heavy timber trusses that bear directly on the four corners of the exterior unreinforced masonry walls further increases the potential risk of roof collapse due to the concentration of roof loads in this relatively weak area.

1. Remove roofing to add ½” plywood/OSB sheathing and replace roofing.
2. Install new in-plane anchors at the roof.
3. Install new out-of-plane anchors at the roof.
4. Install new truss to beam connections.
5. Provide additional column shoring consisting of thru-bolted exterior and interior steel plates at four (4) main truss bearing locations. See Figure 3-A.
6. Inspect for rot damage to wood beams and roofing near location of walls showing signs of water infiltration.
7. Install new in-plane anchors at the floor.
8. Install new out-of-plane anchors at the floor.
9. Provide continuity ties at girder to column connections at the first floor.
10. Verify brick veneer anchorage above all primary exit locations.

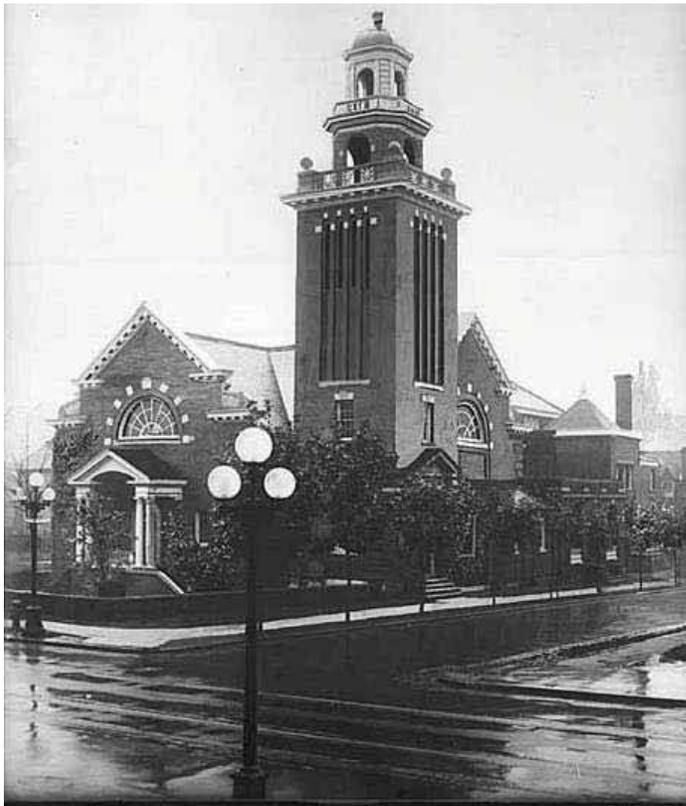
Photo 2: 1906 Bell Tower with Original Cupola – Southwest Elevation

The bell tower is a brick masonry bearing wall structure with four levels of horizontal wood diaphragms resisting lateral loads. The original construction of the bell tower included a masonry cupola structure approximately 20 ft in height that was significantly damaged in the 1949 Olympia earthquake. The cupola as well as most upper exterior ornamental parapets and cornices were subsequently removed. At some point the entrance through the tower changed from the south side to the west side. The tower rests on concrete foundation walls. See Photos 1 and 2.

While we did not observe the interior condition of the bell tower, the exterior appears to be relatively free of cracks. Some signs of water infiltration were observed through the foundation walls in the basement below the tower. In general the bell tower appears to be in good to excellent condition with no obvious signs of settlement or structural distress.

As noted above, the upper portion of the bell tower was damaged in the 1949 Olympia earthquake. To the best of our knowledge there was no damage from either the 1965 SeaTac or 2001 Nisqually earthquakes.

The bell tower is a URM bearing wall structure with flexible diaphragms. Damage from the 1949 Olympia earthquake led to the removal of the cupola (which supported the bells) as well as most of the upper exterior ornamental parapets and cornices. We are not aware of any damage from the 1965 event. In 1995 the bell tower underwent a seismic upgrade. This upgrade can be described in today's terms as an enhanced performance upgrade similar to a "Bolts Plus" upgrade described in the methodology section. To the best of our knowledge the bell tower performed adequately in the 2001 Nisqually earthquake.

In the event of a large code level earthquake, the main concern with the bell tower is having unanchored brick veneer courses fall above the primary exits. This is a life safety issue as the majority of injuries in a major earthquake caused by this type of

structure result from falling debris along public pedestrian walkways. A structural collapse of the bell tower is unlikely due to the geometry and amount of solid walls at its base; however, there would most likely be significant cracking of the masonry piers.

1. Verify brick veneer anchorage above primary exit location.
2. Inspect the interior of the bell tower for signs of earthquake damage or water infiltration and rot.

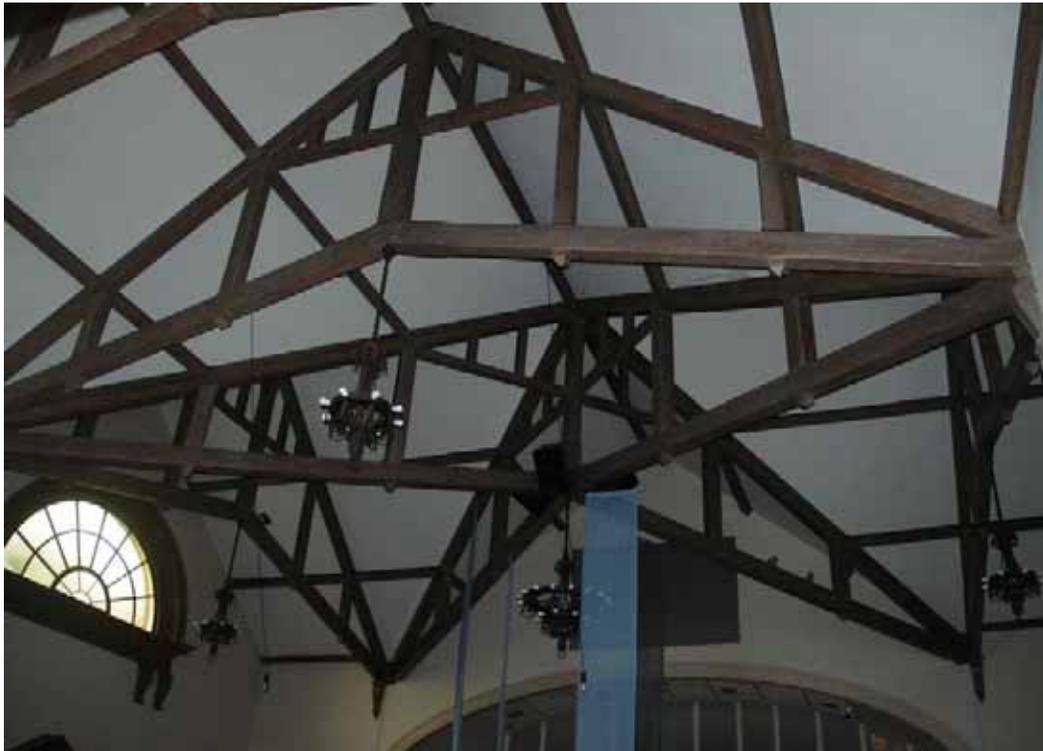
Photo 3: 1906 Sanctuary – Roof Framing

The sanctuary and chapel are best described as masonry bearing wall structures with flexible wood roof and floor diaphragms. The gable roof structure consists most likely of tongue and groove decking spanning to timber beams which in turn are supported by clear span heavy timber trusses that bear directly on the exterior bearing walls. The trusses are laid out uniquely at the center of the sanctuary as they span in the diagonal direction as opposed to perpendicular. See Photo 3. The south and west entry and the north altar area are most likely ship lap decking on 2x joists spanning to either wood beams or bearing walls.

To the best of our knowledge this portion of the church performed adequately in the 1949 Olympia and 1965 SeaTac earthquakes. The 2001 repair documents by IL Gross show some damage from the 2001 Nisqually earthquake where the roof beams frame into the exterior west wall above the original west entrance. The repair consisted of adding anchors to the beam at the wall and adjacent truss connections.

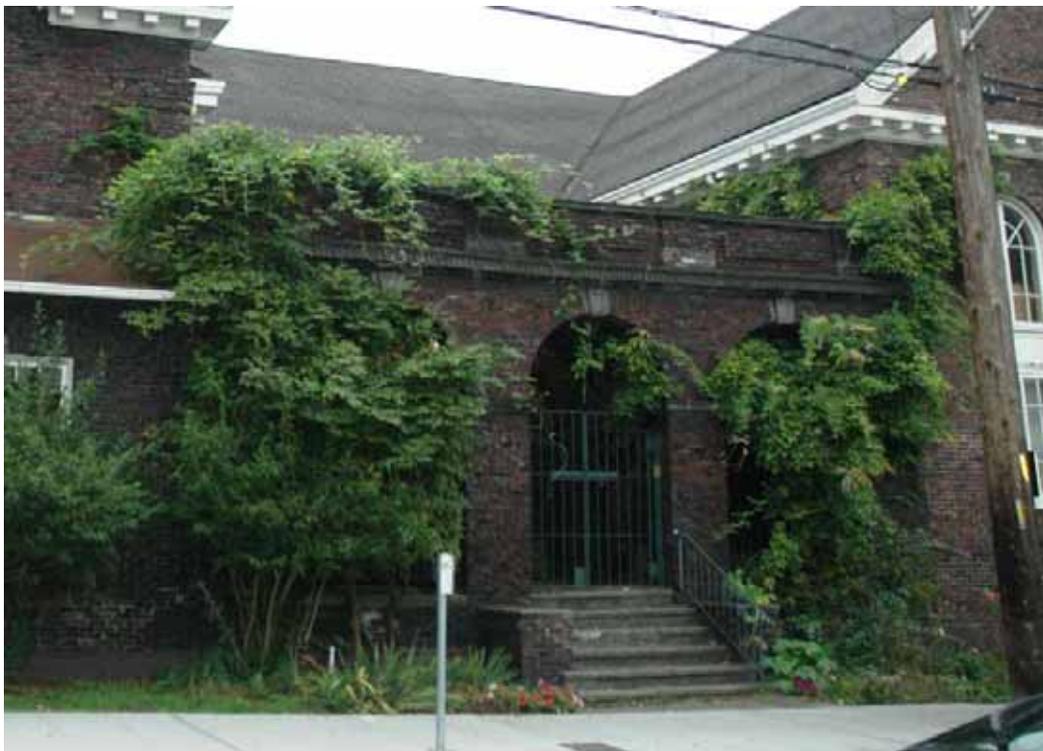
Photo 4: 1906 Courtyard Entryway – South Elevation

Also included in the original 1906 structure is a small courtyard entryway structure adjacent to the south side of the chapel between the 1906 sanctuary and 1928 fellowship hall. It is approximately 30 ft by 8 ft and consists of unreinforced brick entryway arches and wood trellis over brick paving. See Photo 4.

The courtyard entryway area shows signs of ongoing soil settlement. The courtyard entryway structure appears to be in poor to fair structural condition.

The courtyard entryway is a URM bearing wall structure with no diaphragm. It is in poor condition and would most likely collapse in the event of a large earthquake. Although the courtyard appears to be a seldom used area, the structure poses a potential hazard of collapse onto the public pedestrian walkway nearby.

1. Consider removal of the entry archway damaged from ongoing settlement and weathering.
2. If removal is not a reasonable option, repair both the wood roof and masonry arches and columns to restore the entryway to its original condition.

Complete disassembly of the masonry structure, to be rebuilt with new steel frame core covered with the original brick, which would act as a veneer. This will also require significant foundation work.

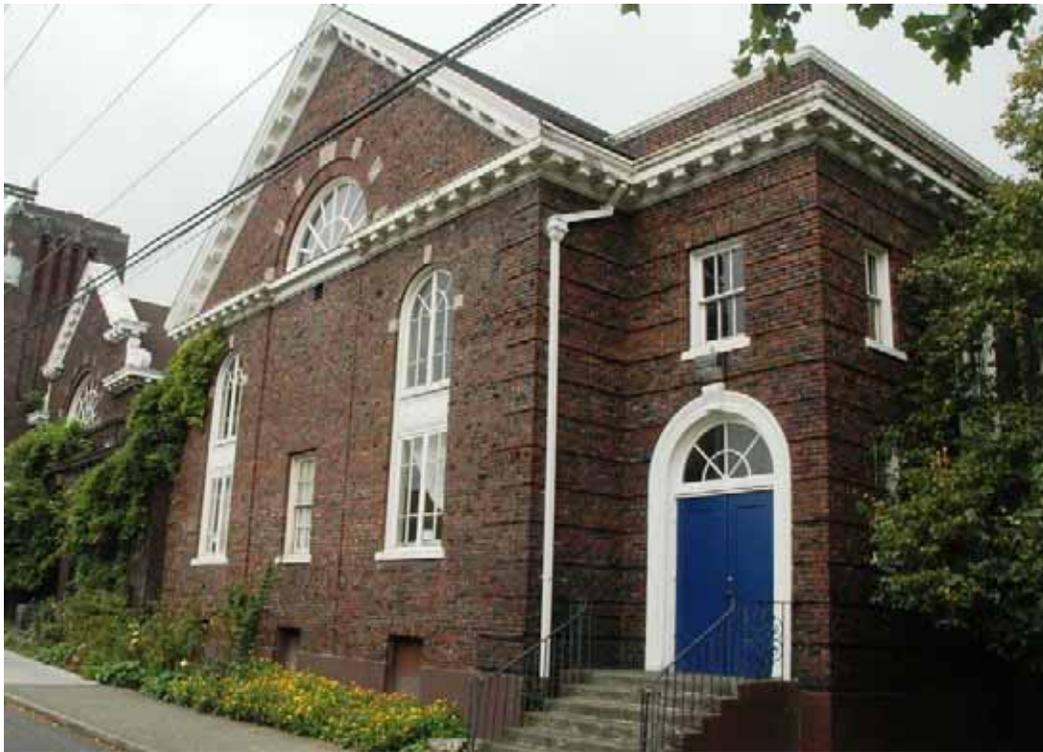
Photo 5: 1928 Addition Fellowship Hall – Southeast Elevation

The overall height to the peak of the fellowship hall gable roof is roughly 40 feet. The fellowship hall's gable roof structure consists of OSB on skip sheathing supported by 2x rafters on wood beams spanning to custom steel trusses. The trusses span the width of the two story hall and are in turn supported by steel columns embedded in the wood framed walls. The barrel shaped plaster ceiling is suspended from the trusses. The steel columns are supported by a concrete foundation wall on the west side and by a concrete beam on the east side located between the fellowship hall and the attached east wing. The floor consists of hardwood over diagonal sheathing supported by 2x joists spanning to wood beams and columns or directly to the foundation walls. There is a large open unfinished basement crawl space below the hall with approximately 7 feet of headroom. The perimeter walls of the crawl space have infilled windows. The foundations appear to be conventional concrete spread and strip footings. See Photos 5 and 6.

The fellowship hall is in good to excellent structural condition. There are no obvious signs of settlement or earthquake damage. The crawl space was moist and appears to lack ventilation which is most likely related to the infilled windows. Deterioration of the brick veneer mortar was observed at the southwest corner. This should be re-pointed as part of an ongoing exterior maintenance program.

This portion of the church is probably the most susceptible to damage during the event of a large earthquake due to the low stiffness and seismic strength of the walls in conjunction with the relatively heavy veneer system.

In the event of a large earthquake, the steel columns supporting the steel roof trusses will most likely protect the main hall from collapse. The surrounding wood stud construction will likely experience large lateral deflections which may cause unanchored brick veneer to fall as well as produce significant damage to the interior finishes. The south gable end wall is very tall and slender making it susceptible to shedding unanchored brick veneer onto public pedestrian walkways below, which is a life safety issue.

The fellowship hall is also poorly attached to its foundation and may slide horizontally off the basement walls in the event of a major earthquake. This may lead to broken gas lines and subsequent fires which in past earthquakes have been more of a life safety issue than damage from the structure itself.

1. Install cold form stud framing with plywood sheathing “strong backs” at inside face of south gable end wall between the roof and lighting balcony level.
2. Verify brick veneer anchorage at gable end wall.
3. Verify brick veneer anchorage above all primary exit locations.
4. Install new out-of-plane anchors at south balcony to gable end wall connection.
5. Provide continuity ties at girder to column connections at the first floor.
6. Provide additional sill plate anchor bolts at top of concrete foundation walls.

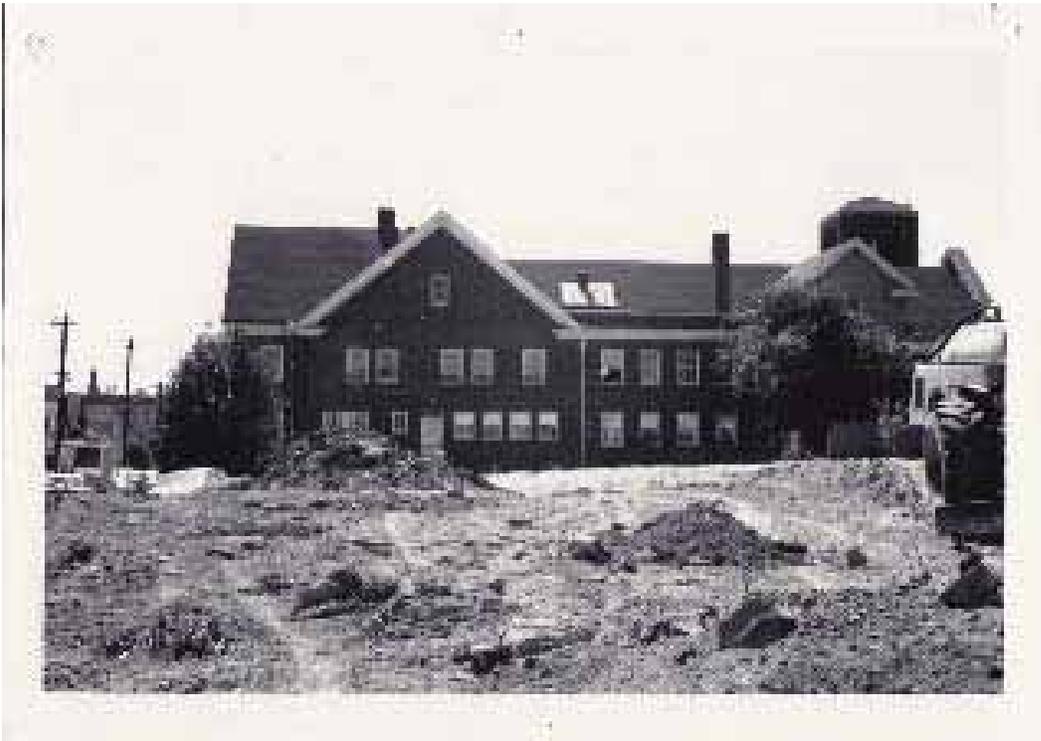
Photo 7: 1928 Addition Classrooms – North Elevation

The exterior walls consist of wood studs and sheathing with brick veneer. The basement level consists of concrete exterior walls with stucco and plaster above grade. The interior bearing and partition walls consist of wood stud framing with lath and plaster. The only exceptions are the concrete walls surrounding the basement boiler room, the 2x laminate walls enclosing the two stairways, and the double tongue and groove fire separation walls. See Photos 7 and 8.

The classroom wing is in good to excellent structural condition. There are no obvious signs of settlement or earthquake damage.

The classroom wing is a wood stud bearing wall structure with masonry veneer. It is poorly attached to its foundation and has two gable end walls that are tall and slender. In the event of a large earthquake, the classroom wing would likely perform better than the fellowship hall; however there may still be significant damage to interior finishes and shedding of unanchored brick veneer from the gable end walls. The tall narrow chimney above the flat roof would likely collapse onto the roof, potentially penetrating the roof structure. Movement of the structure off its foundation could lead to localized failure and broken gas lines which may cause fires.

1. Infill skylights located at the flat roof with wood joists and sheathing.
2. Provide additional bracing at existing brick masonry chimney at the flat roof.
3. Install ½” plywood at inside face of north and east gable end walls in the attic.
4. Verify brick veneer anchorage at gable end walls.
5. Verify brick veneer anchorage above all primary exit locations.
6. Provide additional sill plate anchor bolts at top of concrete foundation walls.

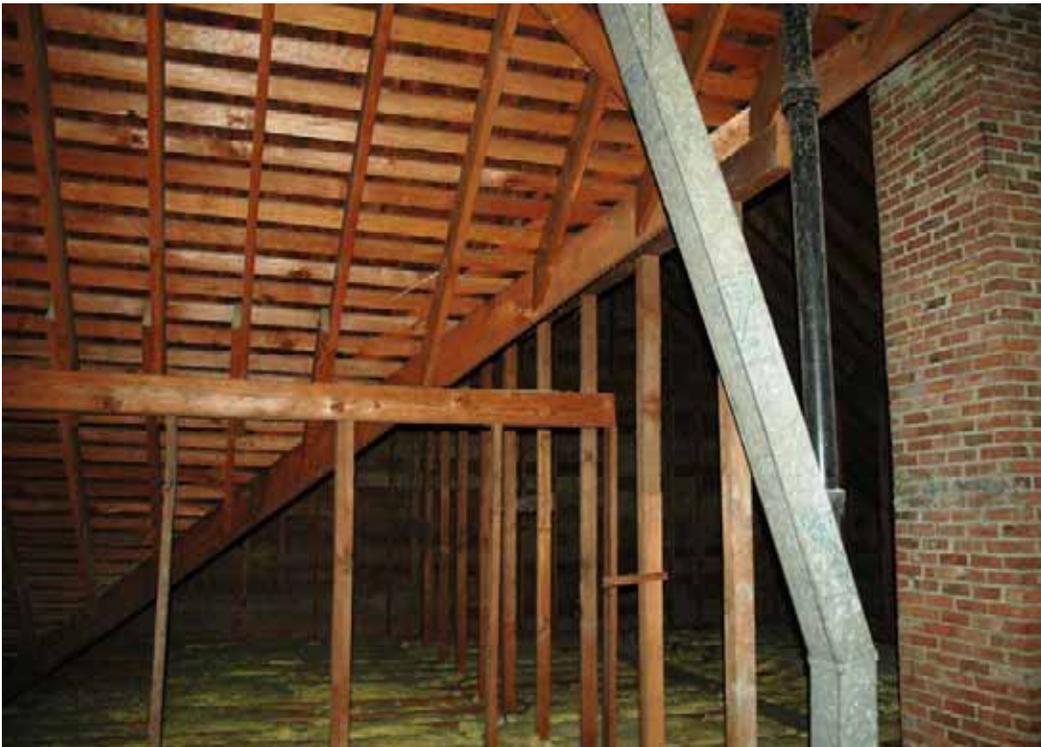
Photo 8: 1928 Classroom Wing – Roof Framing

Similar to the fellowship hall, the classroom wing is best described as a light wood framed structure with flexible roof and floor diaphragms. The gable roof structure consists of OSB on skip sheathing supported by 2x rafters spanning to walls below.

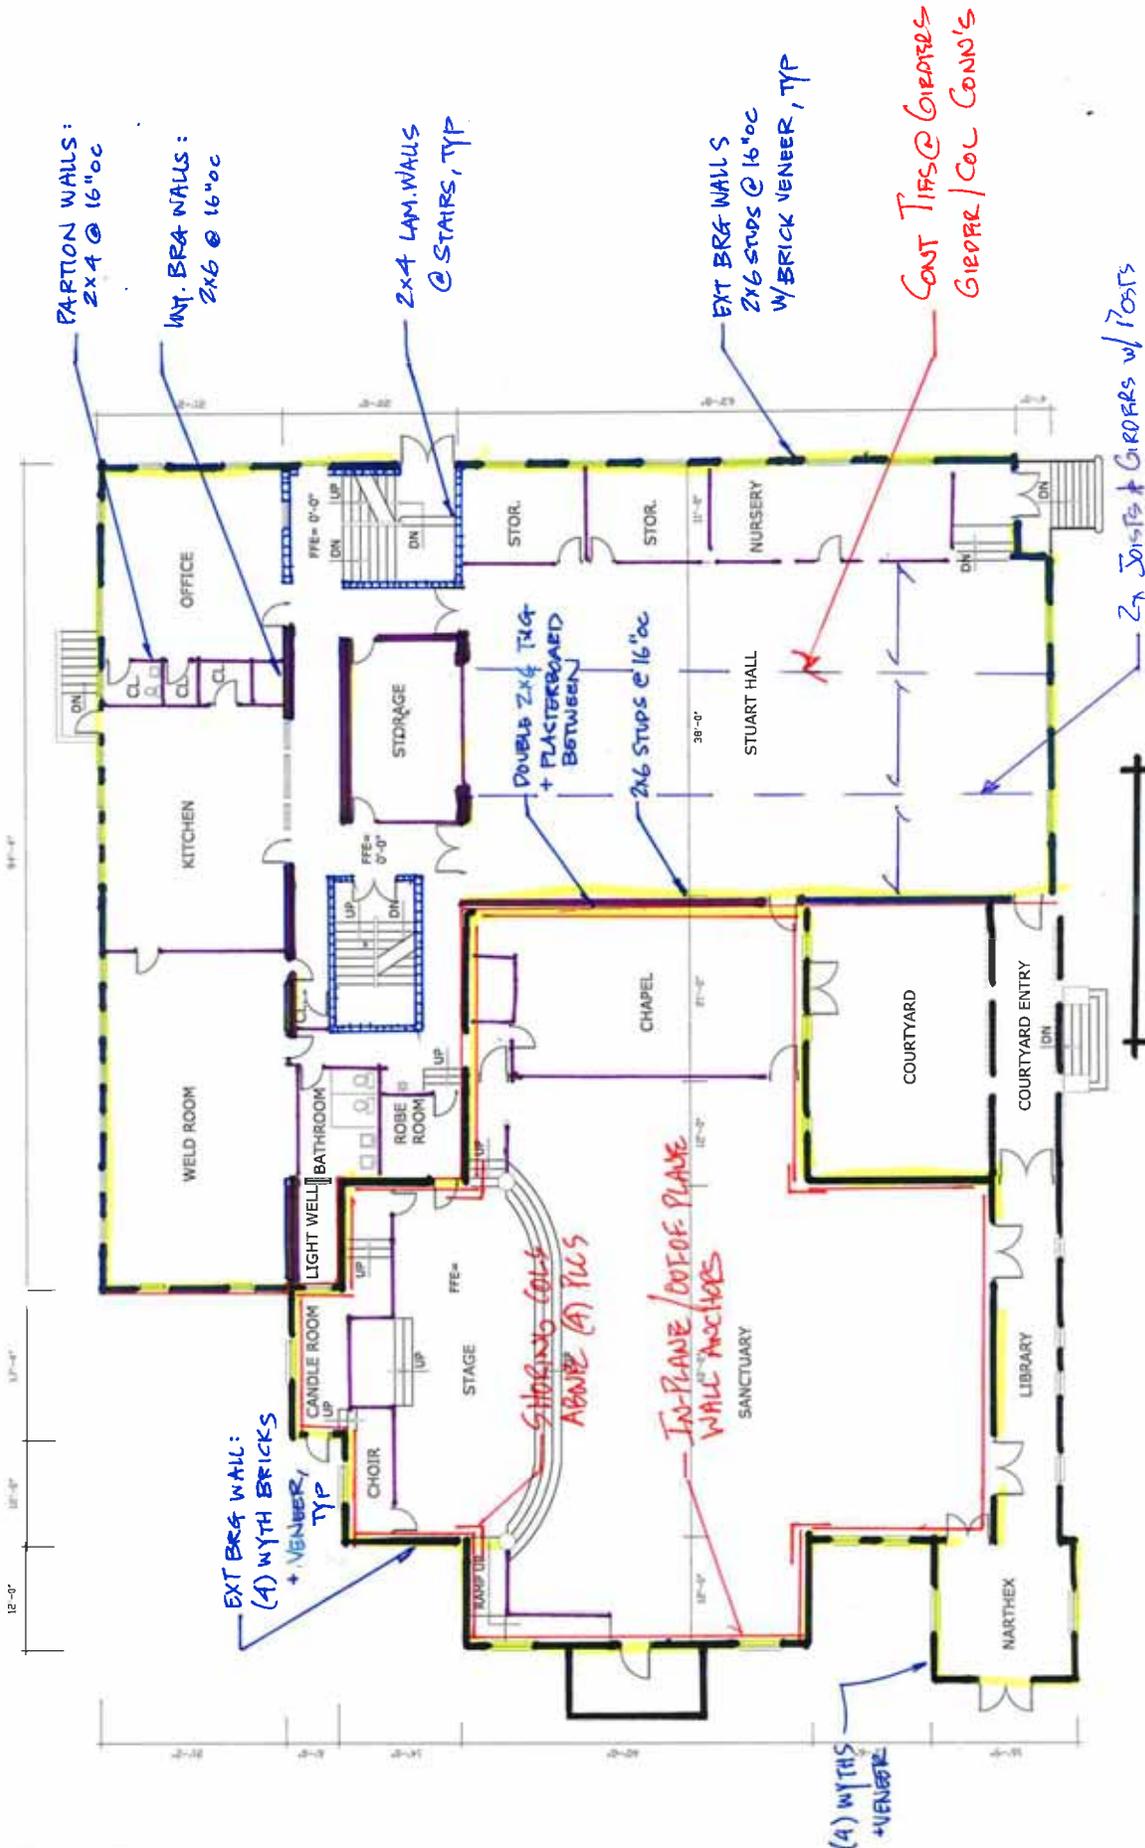
FIGURE 4

FLEXIBLE GAS CONN'S @ BOILER

7. Provide flexible attachments to boiler connection and gas lines.

The proposed seismic upgrades are shown as in red on Figures 2 through 5.
