December 28, 2010

Subject: All Pilgrims Church, Seismic Evaluation/Upgrade

The following report presents a summary of our observations and recommendations regarding the Seismic Evaluation/Upgrade of All Pilgrims Church located in Seattle, Washington.

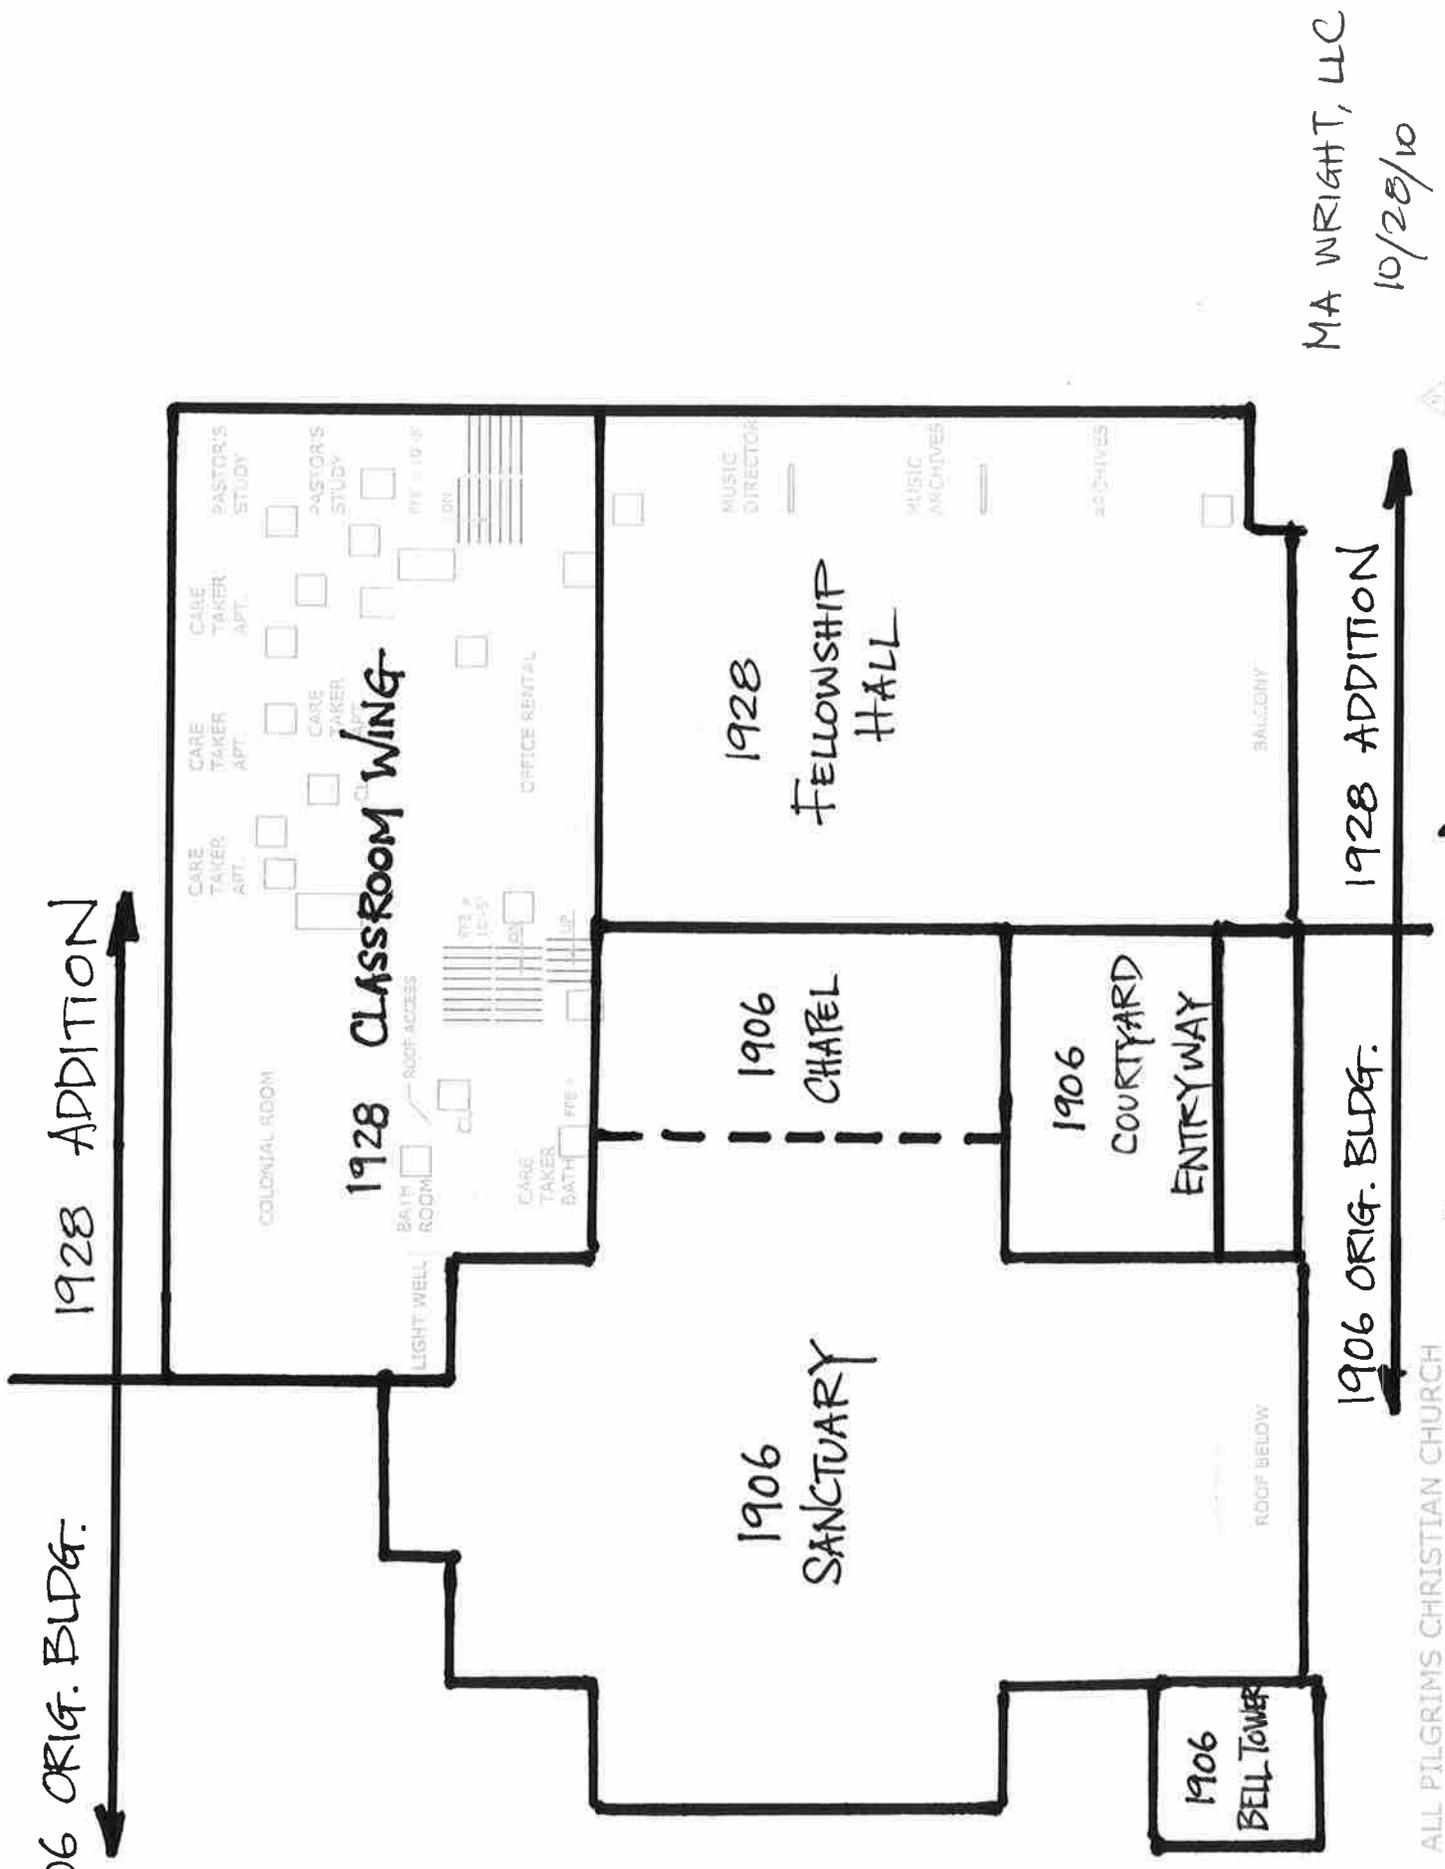
FIGURE 1 | BUILDING PLAN LAYOUT

The church can be divided into five distinct areas consisting of: the original 1906 sanctuary and adjoining chapel, the 1906 bell tower, the 1906 courtyard entryway, the 1928 fellowship hall and the 1928 classroom wing. Figure 1 shows the building plan layout. Existing conditions at each level are shown in Figures 2 through 5.
